## SorbWeb™ Plus

Secondary Oil Containment System

# CASE STUDY

## MAJOR SPILL REMEDIATION

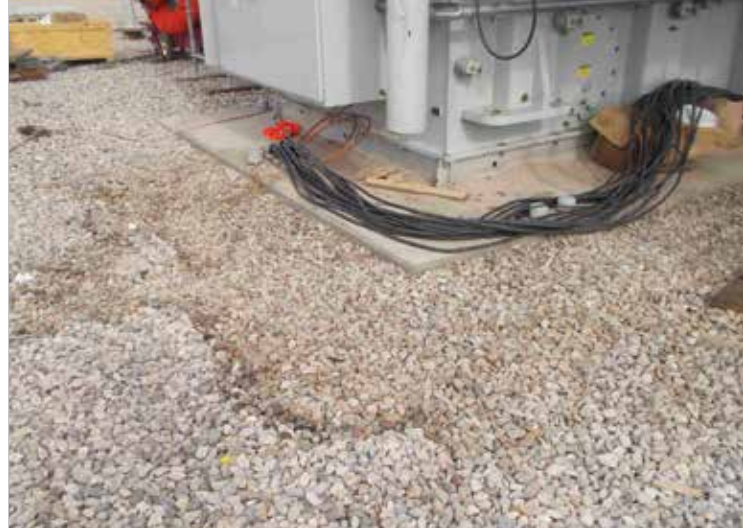
Visual discoloration was observed from the area that came into contact with the oil.

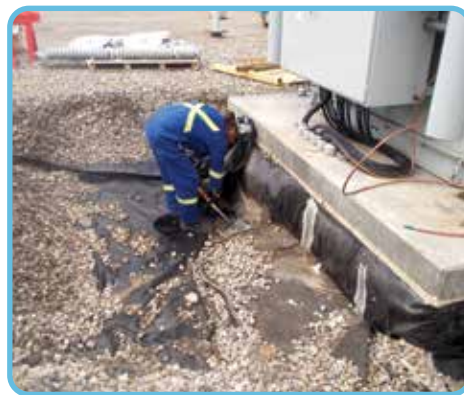
The impermeable liner within the contaminated area was inspected.

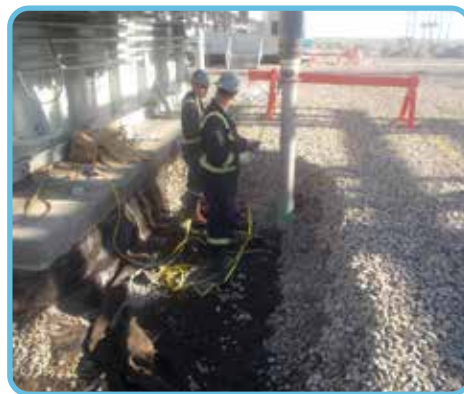
The existing non-woven geotextile showed signs of oil contamination, which was removed and discarded.

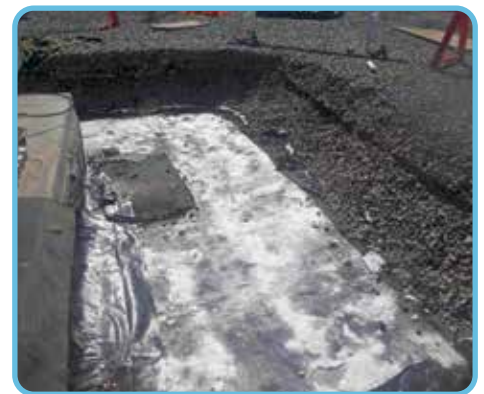
The surface of the contaminated **Alabsorb** layer had noticeable gelling, which indicated a reaction with oil.

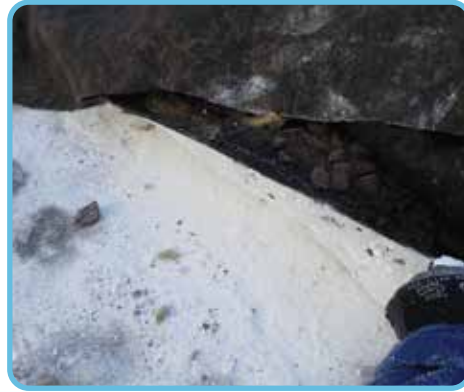
All the contaminated layers were removed until the clean **Oilmat** and **Albasorb** could be seen.

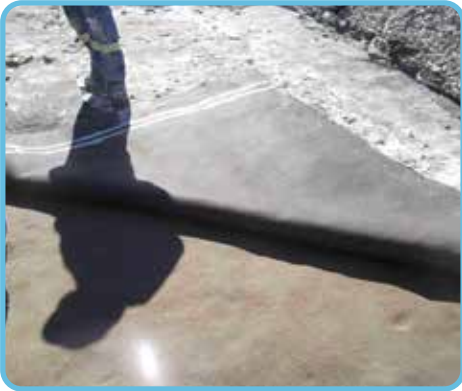
The sand beneath the congealed **Oilmat** was observed to be clean and unaffected by the spill.

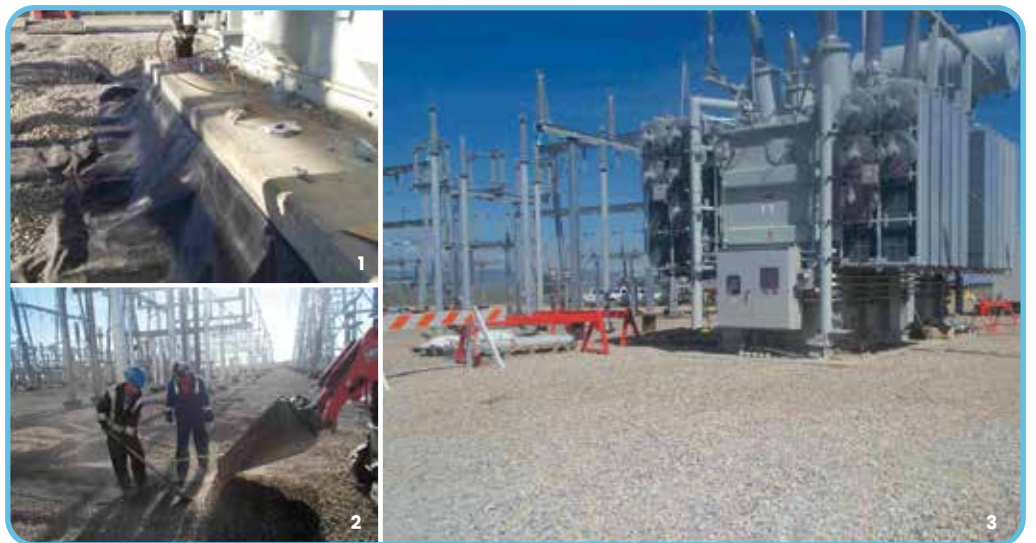
**1.** The sand beneath the congealed oilmat was observed to be clean and unaffected by the spill. **2.** Stone was replaced in the affected area. **3.** The site was cleared of all debris and all equipment was removed from the substation.
