**SORBNSEAL™**  
AN Albarrie PRODUCT

# CASE STUDY

## MAJOR SPILL REMEDIATION

In 2015, a significant oil spill occurred in Southern Alberta for a major electrical utility.

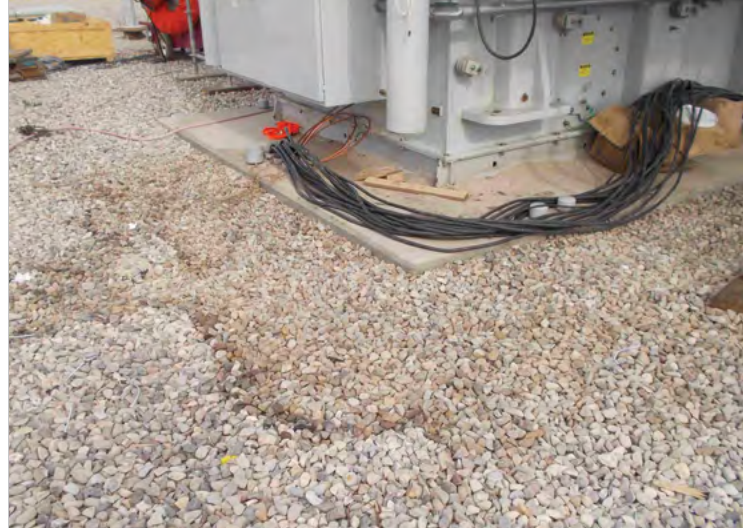
Visual discoloration was observed from the area that came into contact with the oil.

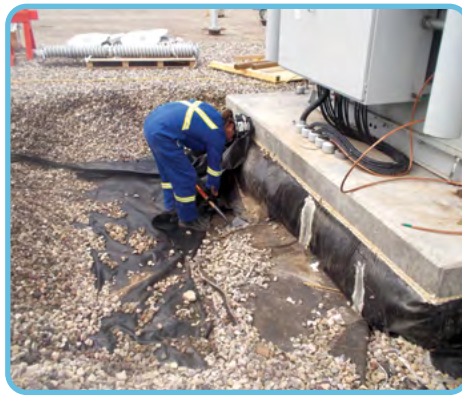
The impermeable liner within the contaminated area was inspected.

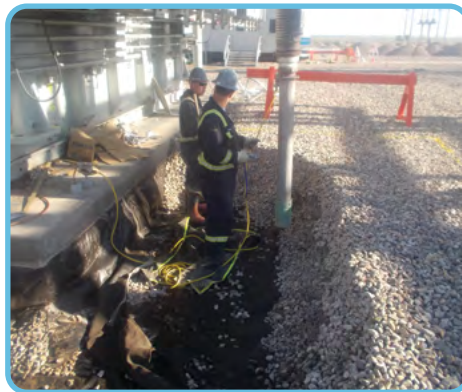
The existing non-woven geotextile showed signs of oil contamination, which was removed and discarded.

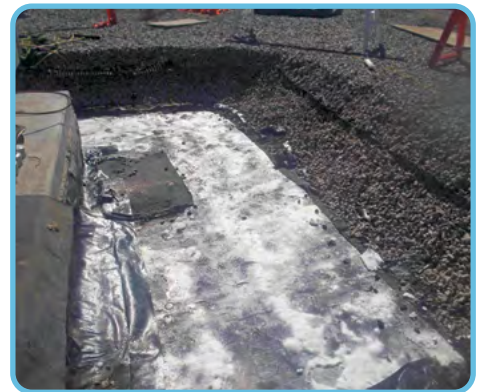
The surface of the contaminated **Alabsorb** layer had noticeable gelling, which indicated a reaction with oil.

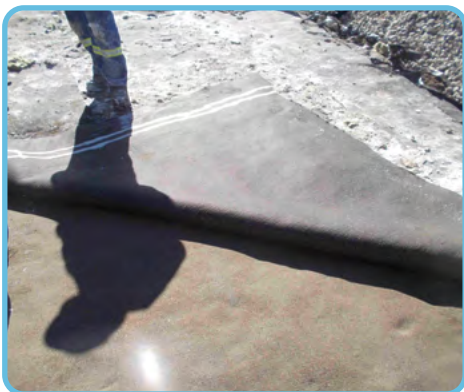
The sand beneath the congealed **Oilmats** was observed to be clean and unaffected by the spill.

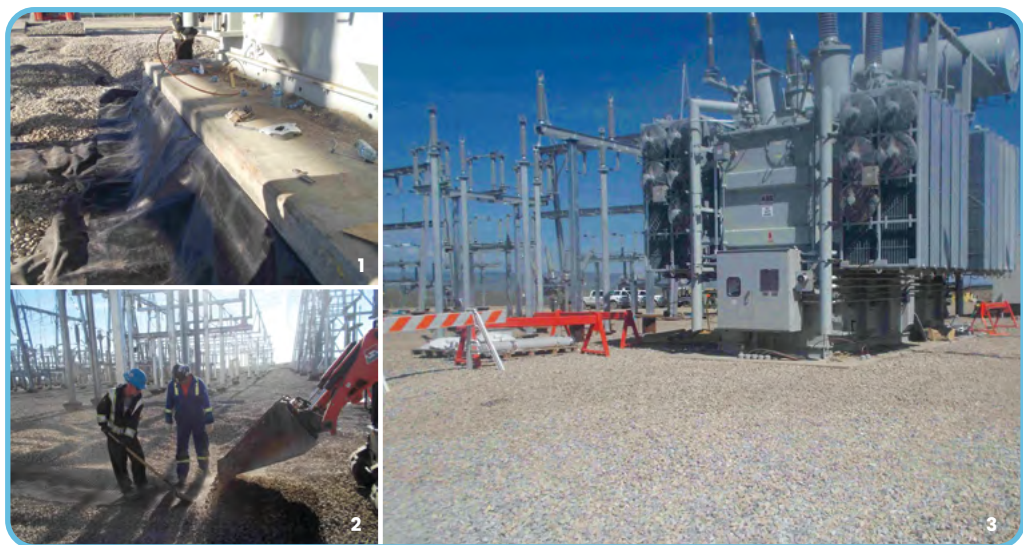
**1.** The sand beneath the congealed oilmats was observed to be clean and unaffected by the spill. **2.** Stone was replaced in the affected area. **3.** The site was cleared of all debris and all equipment was removed from the substation.
