# CASE STUDY

## MAJOR SPILL REMEDIATION

In 2015, a significant oil spill occurred in Southern Alberta for a major electrical utility.

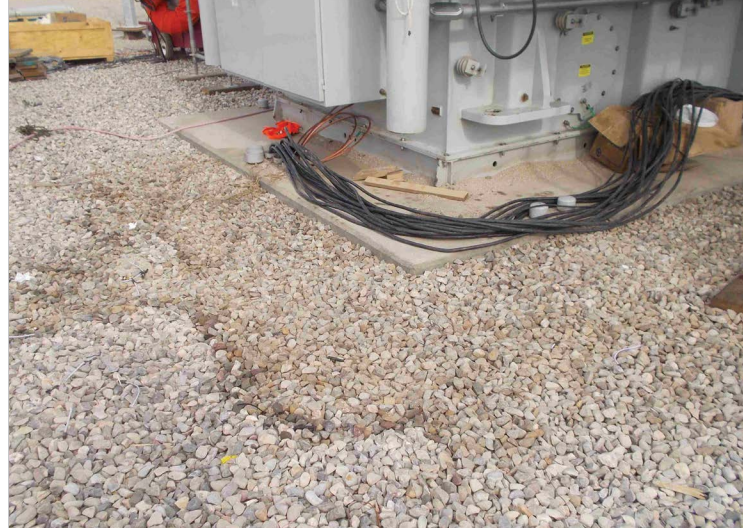
Visual discoloration was observed from the area that came into contact with the oil.

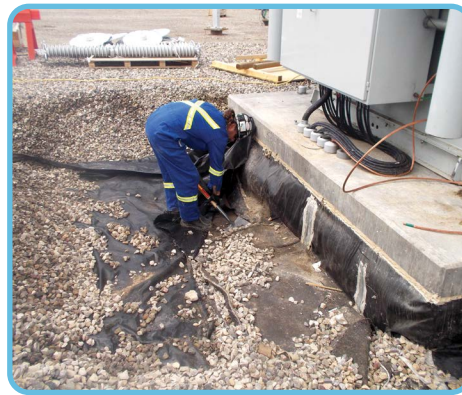
The impermeable liner within the contaminated area was inspected.

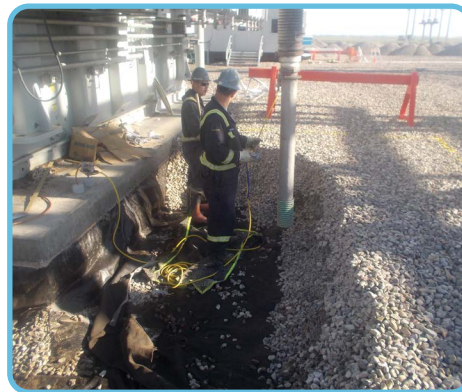
The existing non-woven geotextile showed signs of oil contamination, which was removed and discarded.

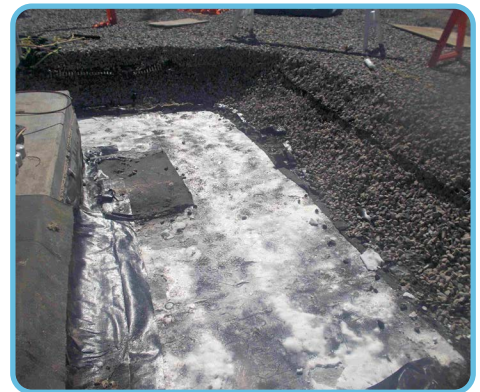
The surface of the contaminated **Alabsorb** layer had noticeable gelling, which indicated a reaction with oil.

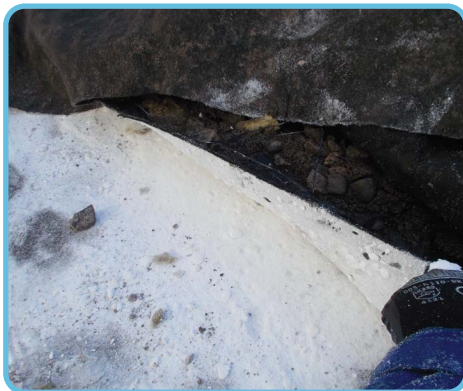
All the contaminated layers were removed until the clean **Oilmats** and **Albasorb** could be seen.

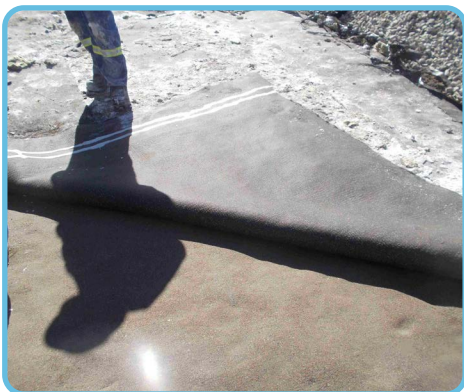
The sand beneath the congealed **Oilmats** was observed to be clean and unaffected by the spill.

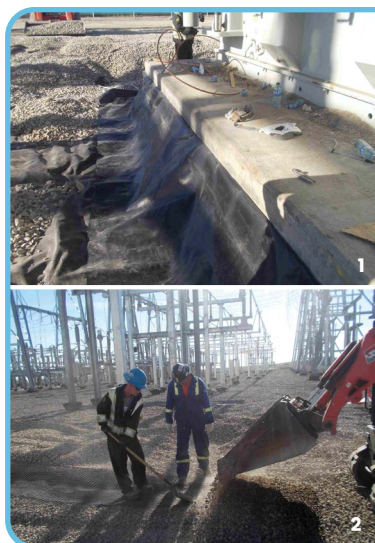
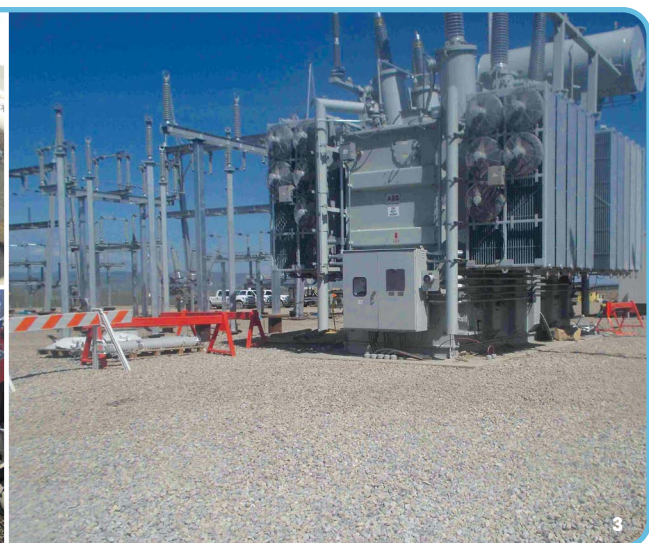
**1.** The sand beneath the congealed oilmat was observed to be clean and unaffected by the spill. **2.** Stone was replaced in the affected area. **3.** The site was cleared of all debris and all equipment was removed from the substation.
