**SORBNSEAL®**  
AN Albarrie PRODUCT

# CASE STUDY

## MINOR SPILL REMEDIATION BACKGROUND

# OIL SPILL REMEDIATION AT TRANSFORMER SUB-STATION

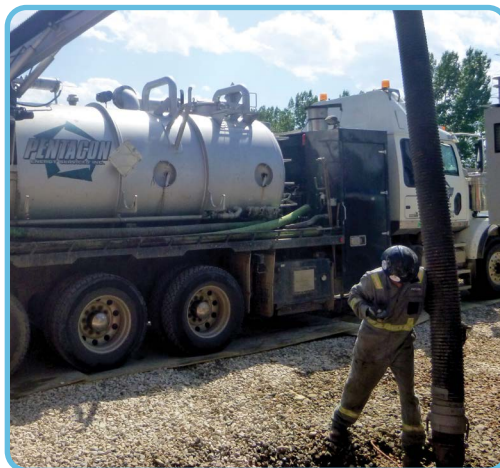
The top layer of surface/ fire quenching stone was removed by Hydrovac truck (left). Some areas were dug by hand (right).

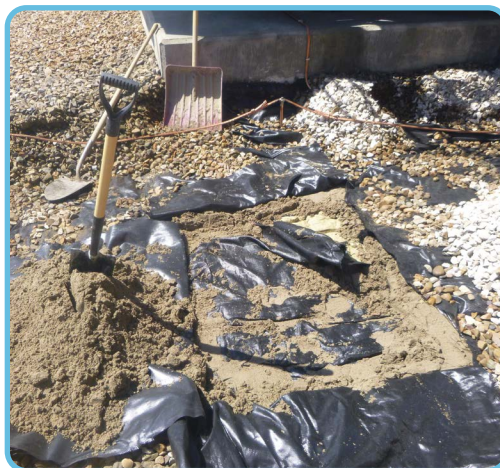
An inspection test area was established in the area that the spill occurred. The top and bottom layers of woven geotextile, two in. (50mm) of sand, and some of the absorbent layer were found to be saturated in this area (left).

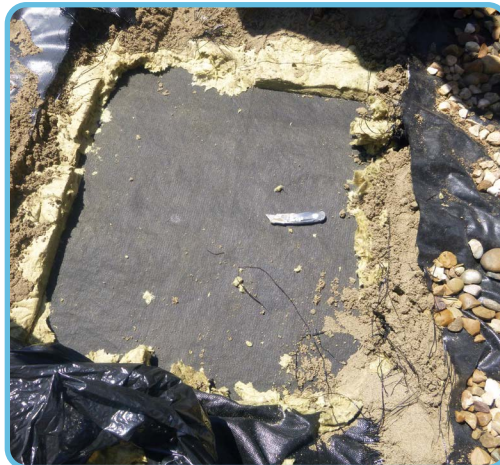
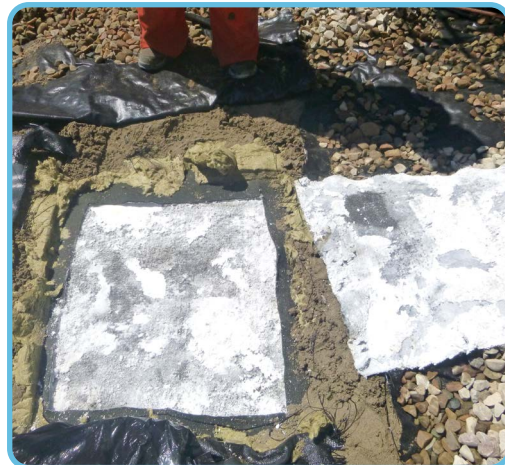
The nonwoven layer also showed signs of oil penetration in this area and was cut out (left), and turned over (right).

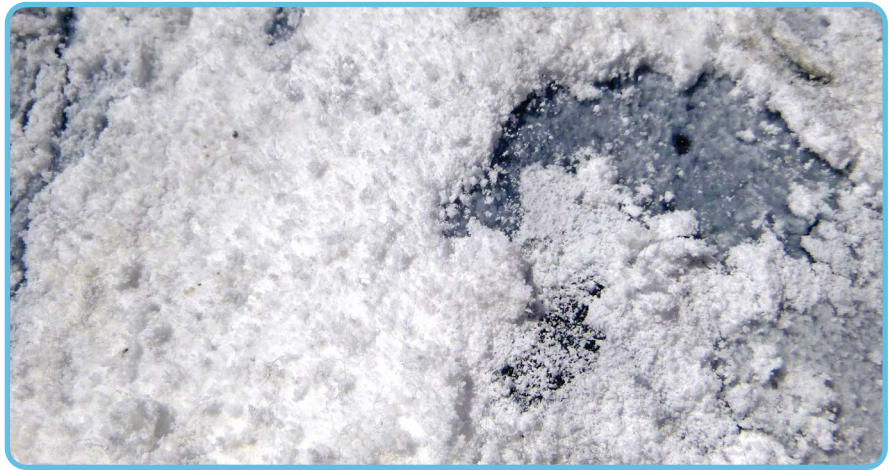
The surface of the **Albasorb** layer had noticeable gelling, which indicated reaction with oil. However, the **Albasorb** was not completely saturated, and the **Oilmat** was unaffected.

Typically, areas near the transformer pad will show signs of full-depth reaction before areas near the perimeter. Unless oil was released under pressure, areas near the outer perimeter are not as affected.

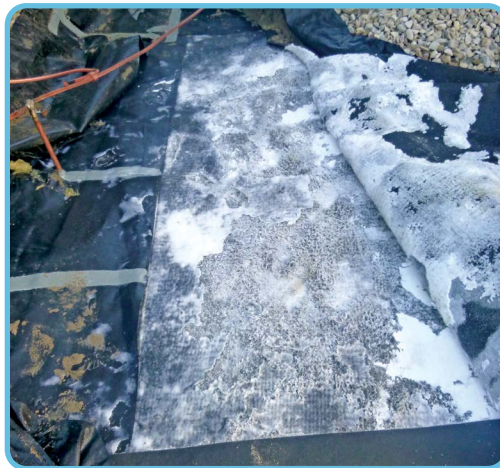
An area near the transformer pad showed signs that the **Albasorb** had reacted fully and oil had reached the surface of the **Oilmat** (left).

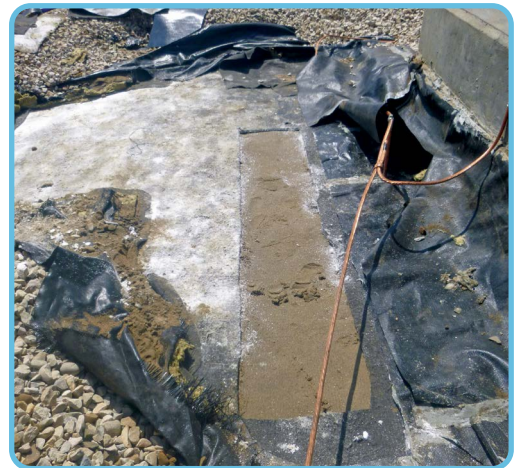
A small section of the **Oilmat** was cut out, which revealed the underlying sand layer that remained unaffected by oil (right).
