## SorbWeb™ Plus

Secondary Oil Containment System

# CASE STUDY

# OIL SPILL REMEDIATION AT TRANSFORMER SUB-STATION

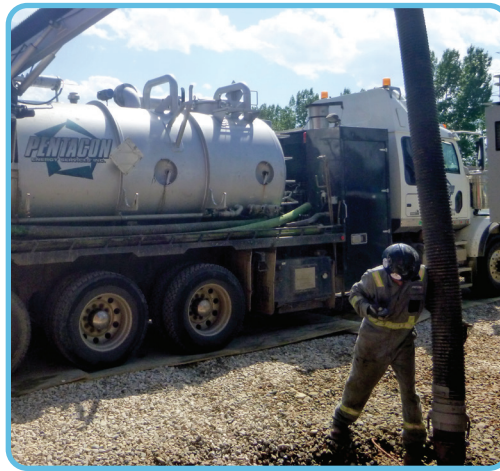
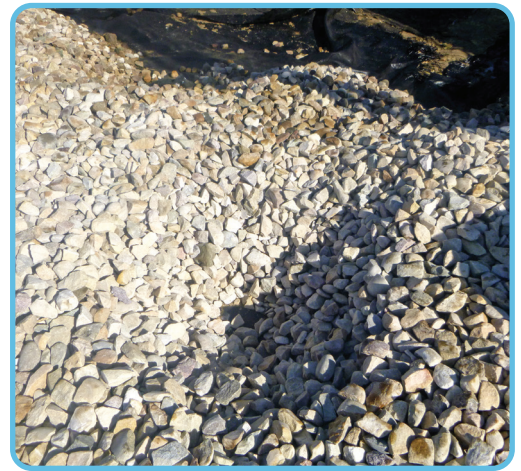
The top layer of surface/ fire quenching stone was removed by Hydrovac truck (left). Some areas were dug by hand (right).

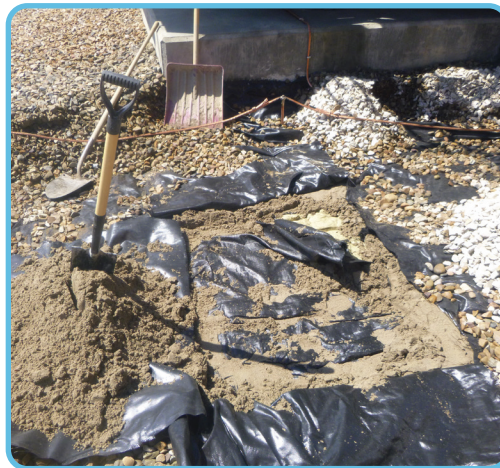
An inspection test area was established in the area that the spill occurred. The top and bottom layers of woven geotextile, two in. (50mm) of sand, and some of the absorbent layer were found to be saturated in this area (left).

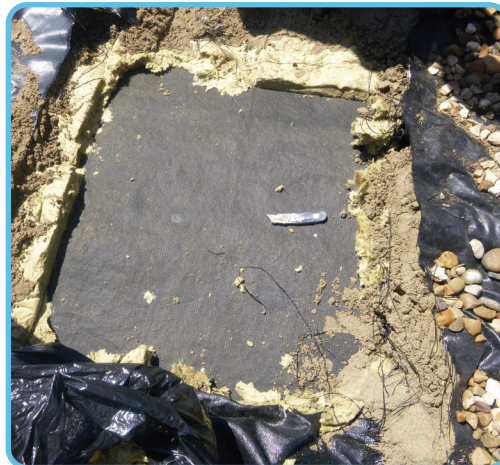
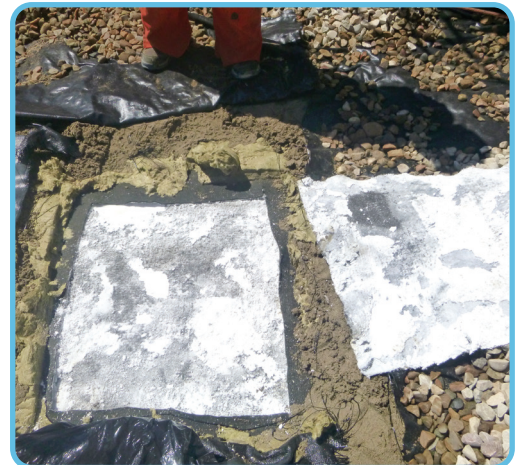
The nonwoven layer also showed signs of oil penetration in this area and was cut out (left), and turned over (right).

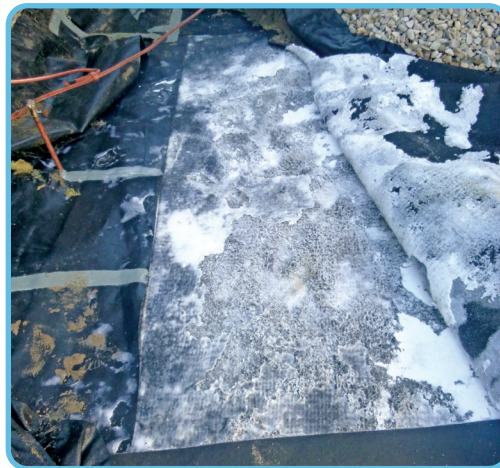
An area near the transformer pad showed signs that the **Albasorb** had reacted fully and oil had reached the surface of the **Oilmat** (left).

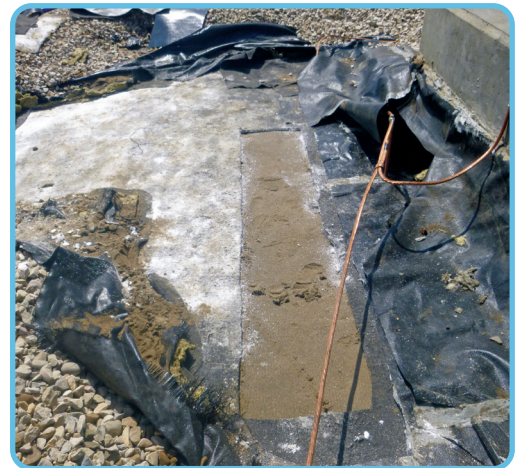
A small section of the **Oilmat** was cut out, which revealed the underlying sand layer that remained unaffected by oil (right).
