# CASE STUDY

## ELECTRICAL SUBSTATION SUCCESSFULLY ADDS A SECONDARY OIL CONTAINMENT SYSTEM.

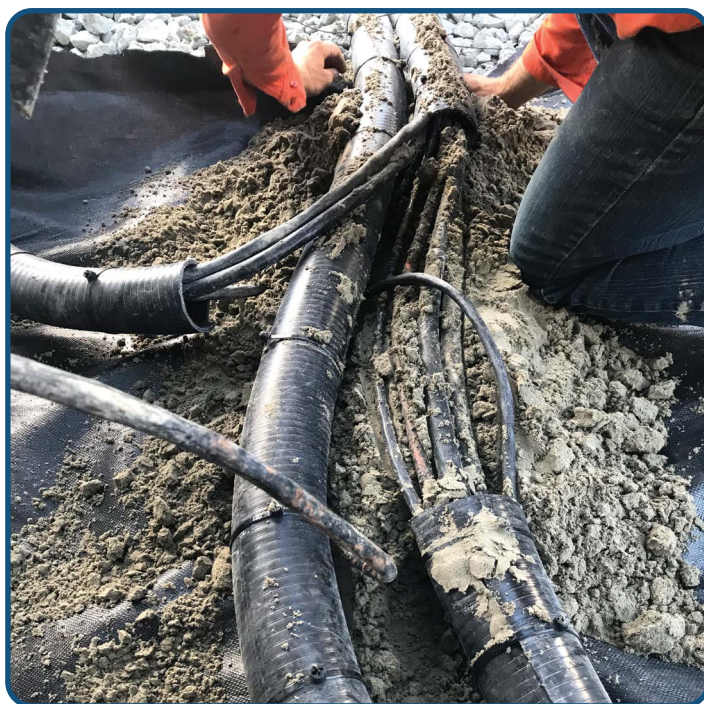
**Albarrie's** engineering team collaborates with the utility during the design phase, relying on client inputs. The consultation usually ensures a smooth, painless install. As with many projects that include aging equipment, unknown obstacles appeared above ground and underground: existing contamination, exposed cables and the site's infrastructure. These challenges required the **Albarrie** team to change plans in realtime while working on-site.

The first challenge the team addressed was existing contamination. **Albarrie's** secondary oil containment system requires clean soil for installation. The utility company hired a third-party consultant to test soil and guide the team on areas that needed remediation, ensuring the oil containment system's integrity moving forward.

The second hurdle was the exposed direct buried underground cables. The challenge required the **Albarrie** team to add protection the cables by encasing them in conduits without moving or disconnecting them while building the containment around them.

Finally, as the **SorbNSeal®** secondary oil containment excavation unfolded, **Albarrie** met several buried structures that required the field team to make design changes to the oil containment in realtime. The design changes accommodated the surprises while meeting the containment volume capacity requirements with minimal impact to cost.

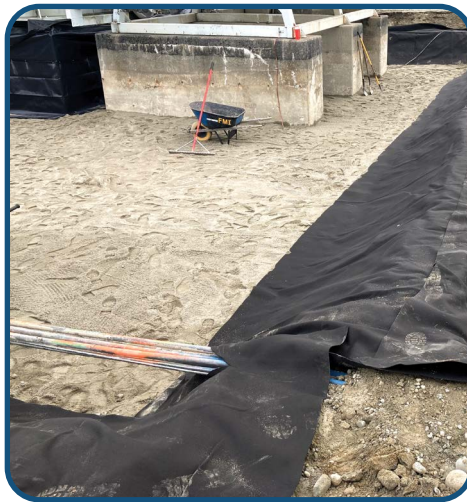
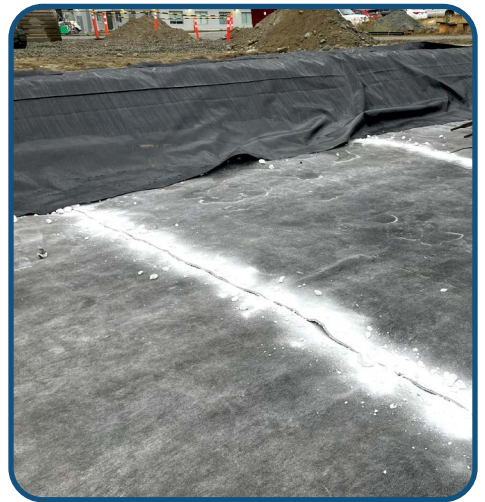
Aging equipment, along with social and governmental demands to protect the environment require utility companies today to address potential hazards lurking in substations, including transformers that currently have no means to contain an oil spill in case of equipment failure. The project included remediating five areas: four reactors and one transformer.

With infrastructure built 60 years ago, we never know what lies hidden beneath the surface. However, through a close working partnership, the **Albarrie** team, and the utility company successfully brought the old substation back into compliance with modern regulations.
