## SorbWeb™ Plus

Secondary Oil Containment System

# CASE STUDY

## MAJOR SPILL REMEDIATION

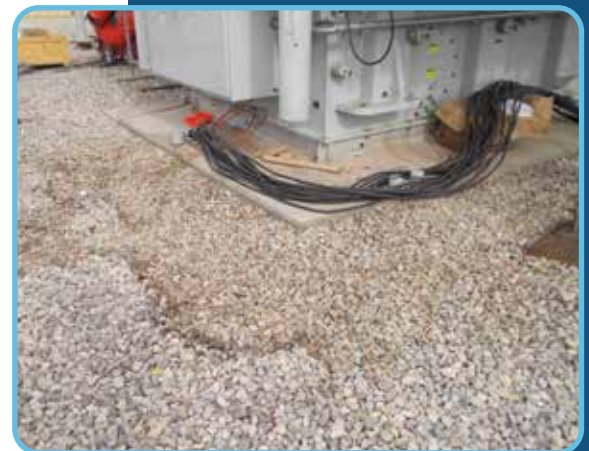
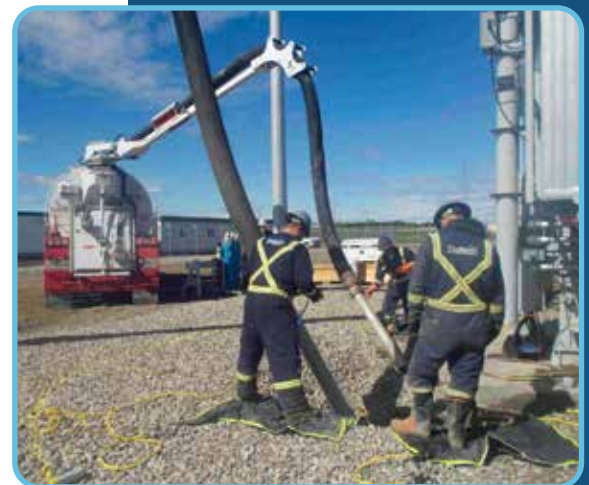
In 2015, a significant oil spill occurred in Southern Alberta for a major electrical utility.

Visual discoloration was observed from the area that came into contact with the oil.
