**SORBNSEAL®**  
AN Albarrie PRODUCT

# CASE STUDY

## MINOR SPILL REMEDIATION BACKGROUND

# OIL SPILL REMEDIATION AT TRANSFORMER SUB-STATION

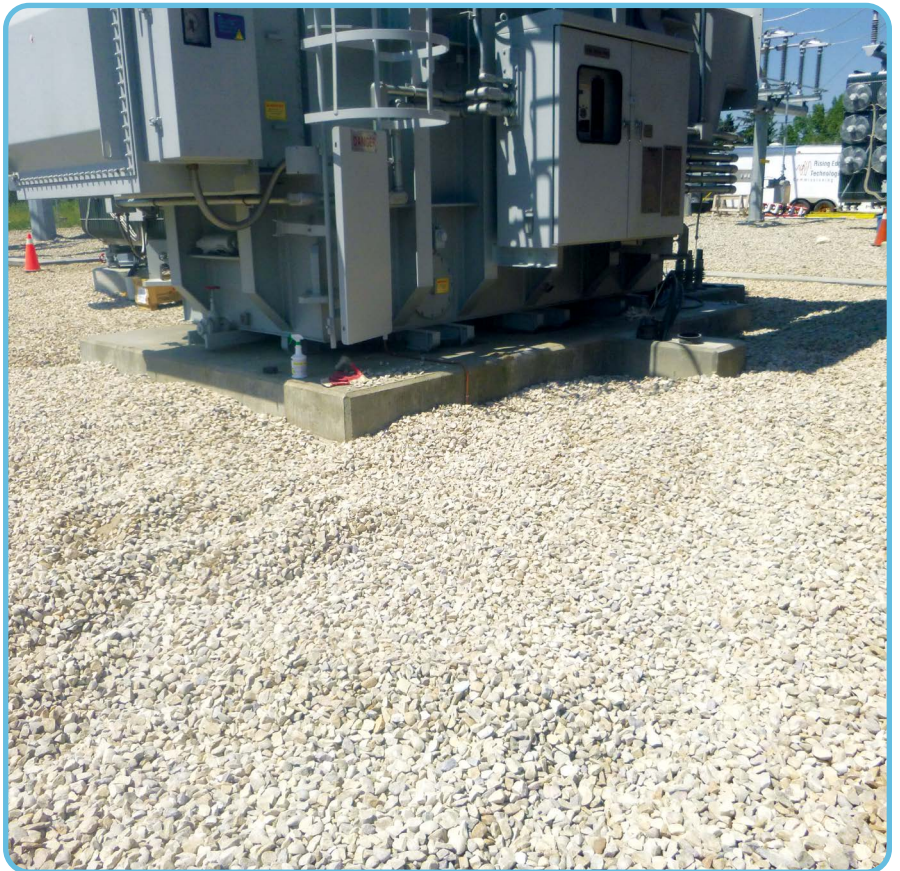
The **SorbNSeal® Secondary Oil Containment System** was effective for this substation transformer. Any oil spilled from the transformer after installation of the containment was contained within the area. Any oil that reached the second lowest layer, the **Oilmat**, did not penetrate into the bottom sand layer or underlying soils.

The **SorbNSeal®** system was optimized to reduce maintenance costs and prevent replacement of the entire system for minor spills. During this minor spill, the **Oilmat** only required a partial replacement within a small area, while other regions required the replacement of less expensive materials, or no replacement of materials at all.
