SorbWeb™ Plus

Secondary Oil Containment System

CASE
STUDY

ELECTRICAL SUBSTATION SUCCESSFULLY ADDS A SECONDARY OIL CONTAINMENT SYSTEM.

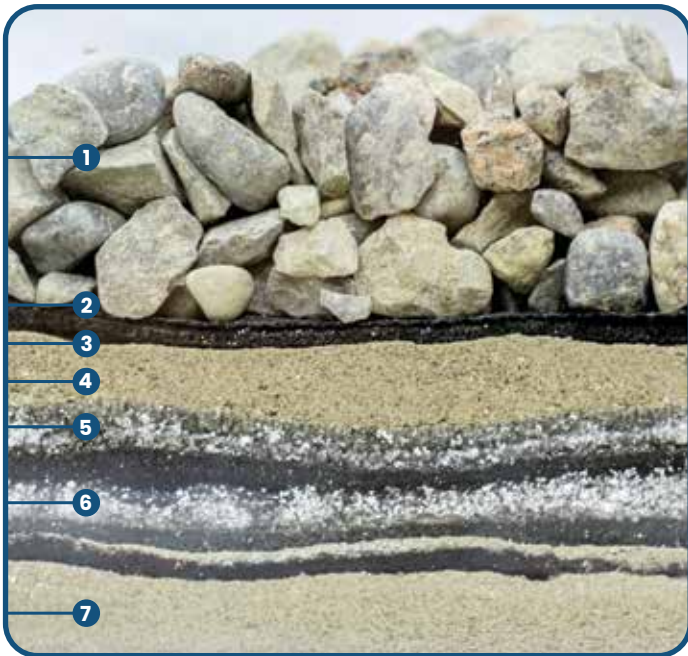
SorbWeb™ Plus with SAM

Albarrie's secondary oil containment system is an innovative, flexible, cost-effective, environmentally-friendly solution custom-designed to meet site specifications and bring companies back into environmental compliance. **Albarrie's** layered system captures 110% of oil volume using a smart oil-adsorbing fabric that seals on contact with hydrocarbons. The fabric allows rainwater to pass through the containment, ensuring the soil's stability. The maintenance-free design meets environmental guidelines from regulating bodies in the U.S. and Canada.

- 1 Fire Quenching Stone
- 2 Woven Fabric
- 3 Nonwoven Fabric
- 4 Sand
- 5 SAM
- 6 Oil Mat
- 7 Sand

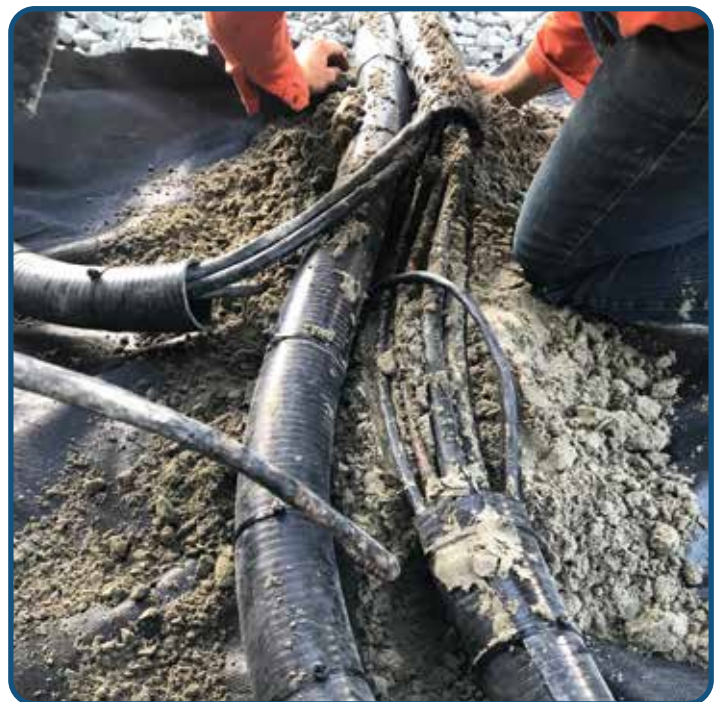
The second hurdle was the exposed direct buried underground cables. The challenge required the **Albarrie** team to add protection the cables by encasing them in conduits without moving or disconnecting them while building the containment around them.

Finally, as the **SorbWeb™ Plus** secondary oil containment excavation unfolded, **Albarrie** met several buried structures that required the field team to make design changes to the oil containment in realtime. The design changes accommodated the surprises while meeting the containment volume capacity requirements with minimal impact to cost.
