SORBNSEAL™
AN Albarrie PRODUCT

CASE STUDY

ELECTRICAL SUBSTATION SUCCESSFULLY ADDS A SECONDARY OIL CONTAINMENT SYSTEM.

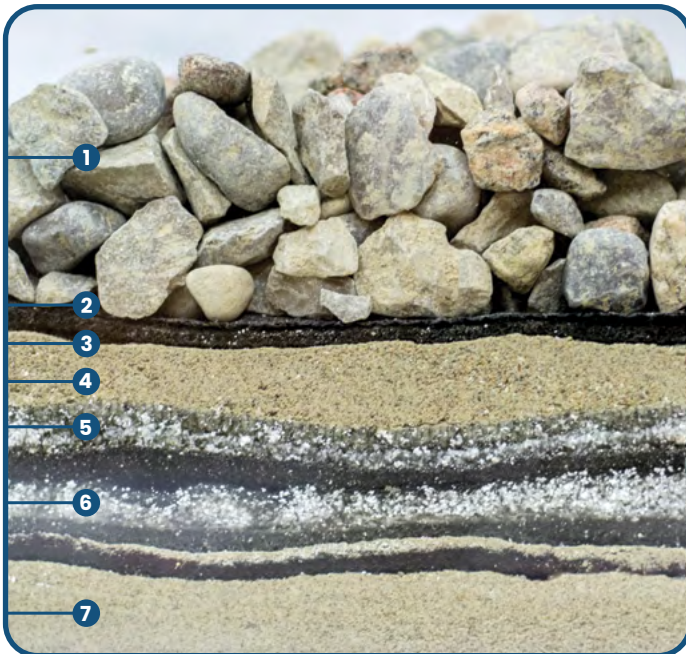
SorbNSeal™ with SAM

- | | |

| 1 Fire Quenching Stone | 4 Sand |
| 2 Woven Fabric | 5 SAM |
| 3 Nonwoven Fabric | 6 Oil Mat |
| | 7 Sand |

Albarrie's secondary oil containment system is an innovative, flexible, cost-effective, environmentally-friendly solution custom-designed to meet site specifications and bring companies back into environmental compliance. **Albarrie's** layered system captures 110% of oil volume using a smart oil-adsorbing fabric that seals on contact with hydrocarbons. The fabric allows rainwater to pass through the containment, ensuring the soil's stability. The maintenance-free design meets environmental guidelines from regulating bodies in the U.S. and Canada.
